City of Baltimore Wet Smoke and Dyed	Page 1 of 2	
Sewershed: Gwynns Falls	Company: Savin	Date: 4/23/2009
Test to be performed: Smoke Dyed Water X	Ground Condition: Dry ✓ Damp ☐ Wet ☐	Supervisor: <u>JAW</u>
Manhole_ID: S03K 015MH	Test ID: <u>D1032-002005</u>	Notification Made: NA (Residents, Fire, 311)

City of Baltimore Wet Smoke and Dyed	Page 2 of 2	
Sewershed: Gwynns Falls	Company: Savin	Date: 4/23/2009
Test to be performed: Smoke Dyed Water X	Ground Condition: Dry ✓ Damp □ Wet □	Supervisor: JAW
Manhole_ID: S03K_015MH	Test ID: <u>D1032-002005</u>	Notification Made: NA (Residents, Fire, 311)

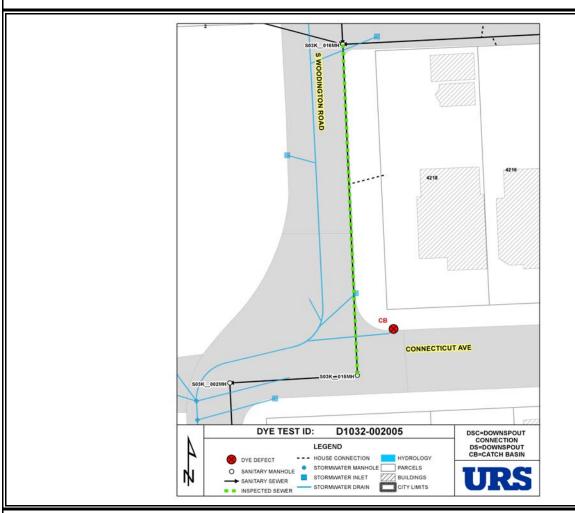
Field Sketch: Show all manholes with Numbers, Blower Placement Locations, Sandbag or Isolation Locations, Street Names, Building Addresses and Locations, Defect Locations and Photo Numbers.

Defect Loc	Obs_ClockFrom	Obs_ClockTo	Observation	Obs_Remarks
0			Manhole	S03K015MH
14.60000038			Dye Test Visible	@ IR, 1/16 GPM
14.60000038	04		Infil Runner	
16.5			Dye Test Visible	@ IR & FC,4 GPM
16.5	03	10	Infil Runner	
16.5	08	09	Fracture Circumferential	
19.39999962			Dye Test Visible	@ IR, 1/2 GPM
19.39999962	07		Infil Runner	
21.39999962			Dye Test Visible	@ IR, 1/2 GPM
21.39999962	08		Infil Runner	
25.20000076			Abandoned Survey	NO MORE DYE VISIBLE
